## Water outlet

SH060 Description

Cilindrical water outlet

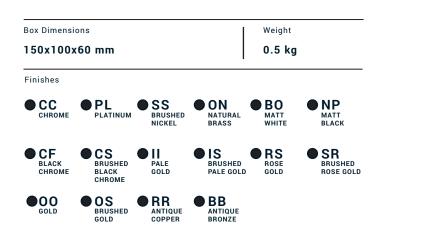
Dimensions

Cartridge -	Threaded fitting G1/2" male			
Aerator	Flow Rate (+/-10%)	Flow Rate (+/-10%)		
	1 BAR - I\m	2 BAR - I∖m	3 BAR - I\m	
	·

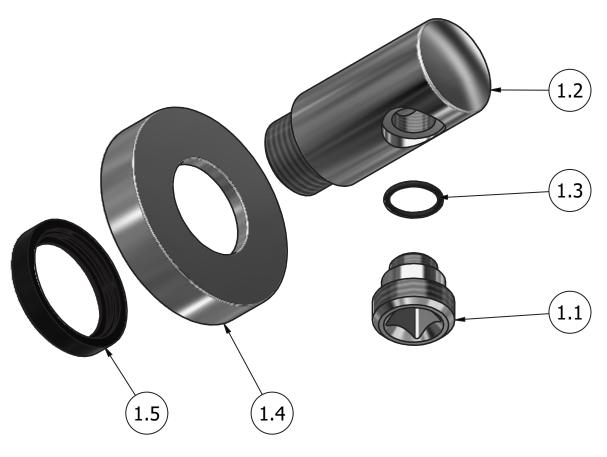
ELENCO PARTI				
ELEMENTO	CODICE	DESCRIZIONE	QTÀ	
1	AQ0017133	Cilindrical water outlet	1	
1.1	AQ0017133_1	G1/2" for water outlet	1	
1.2	AQ0017133_2	Body water outlet	1	
1.3	AQ0017133_3	O-Ring	1	
1.4	AQ0017133_4	Ceiling Ø54.5 H11.5	1	
1.5	AQ0017133_5	Gasket	1

### Main body is a single hot stamped pieces

BRASS According to CuZn39Pb3 (CW614N) Max Lead content: 2.5%
